ASBESTOS TYPE 2 SURVEY REPORT

Warmsworth WPS
Oakdale Road
Warmsworth
Doncaster
DN4 9

SAI 00001363

J0633-0001

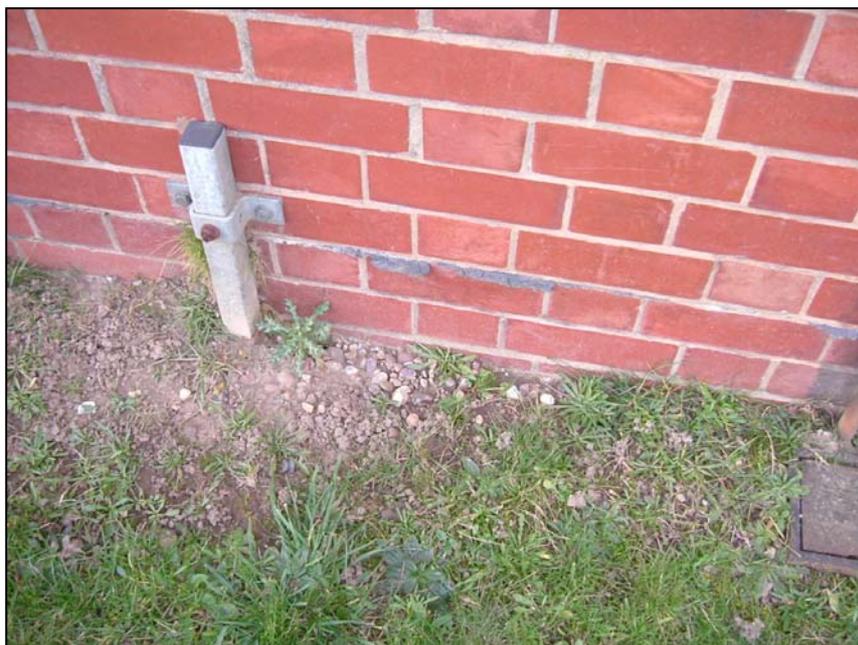
Sample Reference No: 001
Position: External
Approx Size of Item: 30 lin m

Client:	Yorkshire Water Plc	Area No:	EXT
Site Address:	Warmsworth WPS, Oakdale Road, Warmsworth, Doncaster, DN4 9	Floor:	Ground
Building:	Water Pumping Reservoir	Area Description:	External
Building Address:	As Above	Material Description:	Damp proof course
		Survey Report Reference:	J0633-0001-0001

Material Risk: 0
Asbestos Type: 0 - No asbestos detected

Extent of Damage: Not asbestos

CAWR Recommendations: No asbestos present

Surveyor's Recommendation / Comments: No further action required
